# Parametric Optimization of TIG welding and Defect Identification using Non Destructive Testing Methods

**ABSTRACT**: This paper aims to study about the process of tungsten inert gas welding and the defects arises on the TIG welding using various non destructive testing methods. TIG welding is the one of the most popular gas – shielding arc welding process used in many industrial fields. In this investigation the optimization of process parameters of tungsten inert gas (TIG) welding of ASTM A36 carbon steel is done. Various non destructive testing methods are carried out to identify the defects on the TIG welding specimens. Non destructive testing methods are the wide group of testing methods used to evaluate the properties of a material, component or system with out causing damage. In this study visual inspection, liquid penetrant inspection, radiography testing, and ultrasonic testing is used to identify the defects in the weld samples.

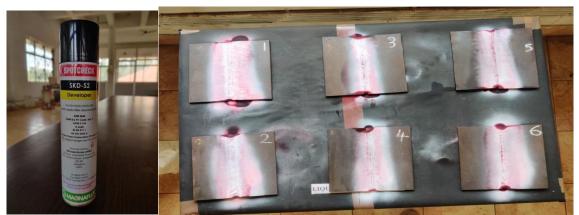
Fig3.3 SKD-S2 developer and test samples after developer application.

A small layer of developer is then applied to the sample to draw penetrant trapped in flaws back to the surface where it will be visible. In this experiment MAGNAFLUX brand SKD-S2 is used as the developer shown in figure 3.3. It is a blend of inert inorganic particles suspended in an isopropanol and acetone mix. The SKD-S2 developer is applied directly to the specimen surface. And wait until the dwell time.

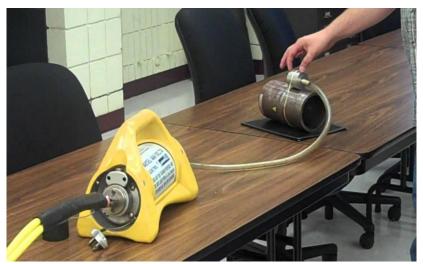
Fig 3.5 radiography testing machine.

Two of the most commonly used sources of radiation in industrial radiography are x-ray generators and gamma ray sources. Industrial radiography is often subdivided into "X-ray Radiography" or "Gamma Radiography", depending on the source of radiation used. The radioactive "capsule" is attached to a cable to form what is often called a "pigtail". The pigtail has a special connector at the other end that is attached to a drive cable. A device called a "camera" is used to store, transport, and expose the pigtail which containing the radioactive material. The camera contains shielding material which helps to reduces the technicians exposure to radiation during use. A hose-like device called a guide tube is connected to a threaded hole called an "exit port" in the camera. The radioactive material will leave and return to the camera through this opening when performing an exposure. A "drive cable" is connected to the other end of the camera. This cable, controlled by the technician, is used to force the radioactive material out into the guide tube where the gamma rays will pass through the specimen and expose the recording device. Single wall single image technique (SWSI) is employed in this testing. The gamma ray source used for this radiography testing is IRIDIUM192 (ir192) with a strength of 10 curies (10ci). The size of the gamma ray source is  $2.7 \text{ mm} \times 2.9 \text{ mm}$ . The film used for the testing is AGFA D7. A 20 Inches of source to film distance (SFD) is fixed for producing proper exposure rate. 5 minutes of exposure time is given to produce sufficiently exposed radiography film. A lead screen of thickness 0.1mm in front and back is used for cutting of the low intensity scattered radiations. The weld surface irregularities shall be removed by any suitable process to such a degree that the images of surface regularities cannot mask or be confused with the image of any discontinuity on the resulting radiograph. The test specimen is place in between gamma ray source and film. The required source to film distance is fixed. And exposure process is carried out for required time. After exposure the film is developed, Processing shall be done manually in air conditioned and dark room free from light leakages.
